# Monitoring Restoration Effectiveness on the Lower Rio Blanco River

J.D. Kurz<sup>1</sup> and D.L. Rosgen<sup>2</sup>

Wildland Hydrology, Pagosa Springs, CO

# Lower Rio Blanco River near Pagosa Springs, Colorado

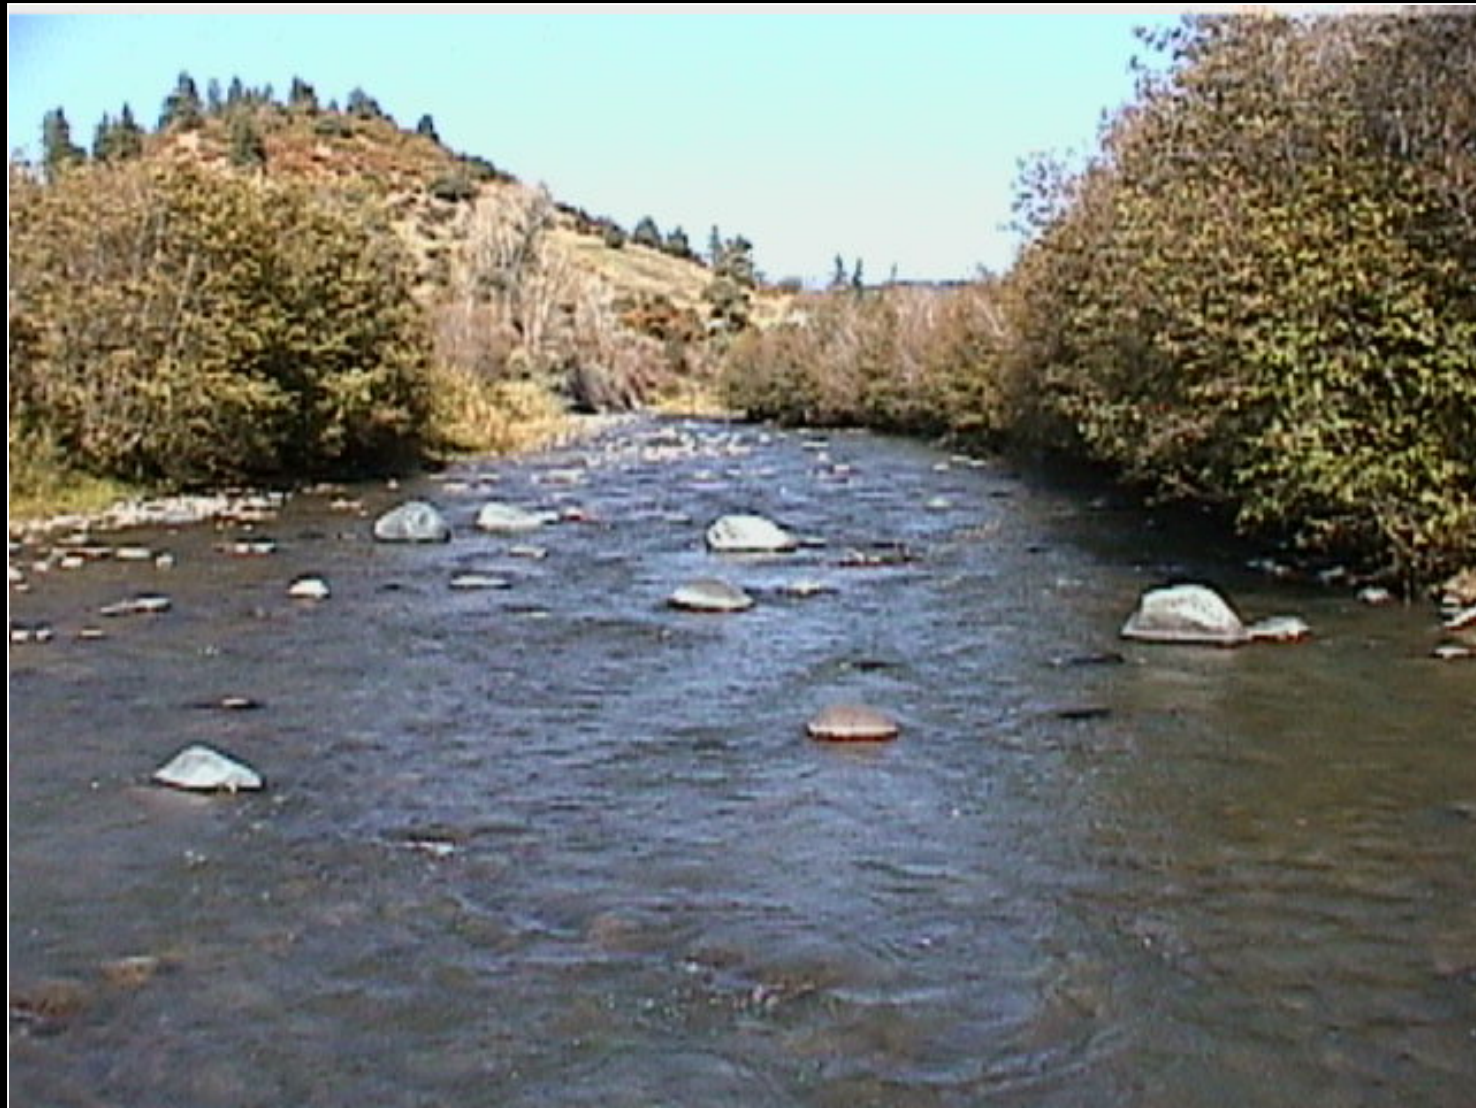
Typical photograph showing the wide, shallow channel at low flow prior to restoration

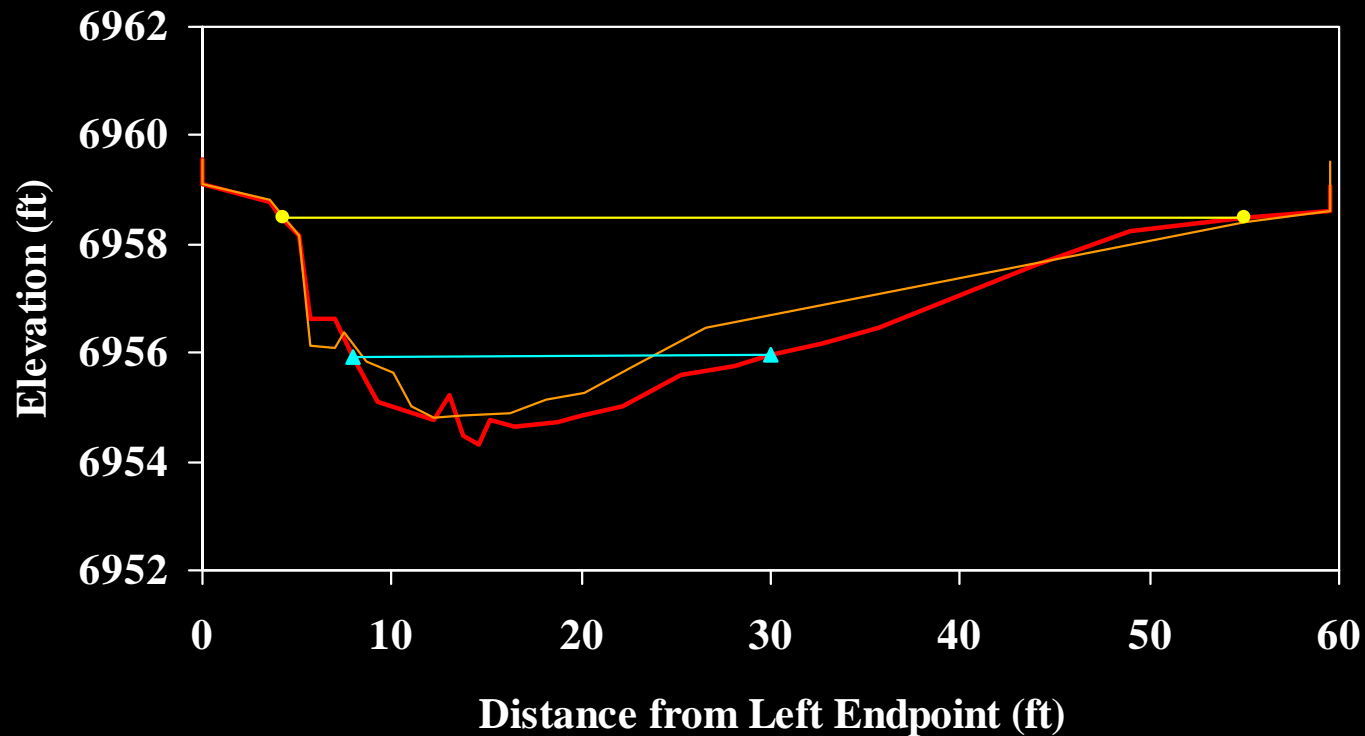
# Cross Section A

Discharge	Width	Mean Depth	Width/Depth Ratio	Max Depth
18 cfs	22.0 ft	0.81 ft	27.1	1.6 ft

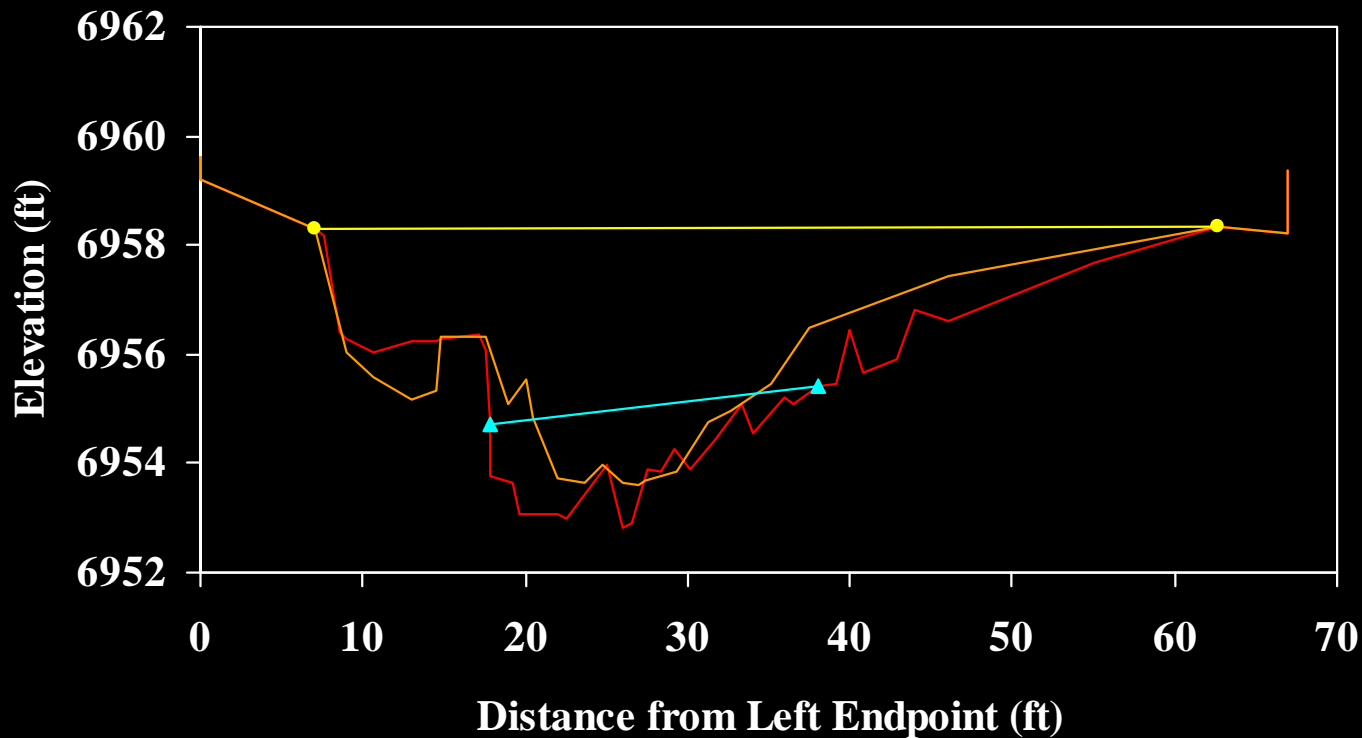
# Cross Section B

Discharge	Width	Mean Depth	Width/Depth Ratio	Max Depth
18 cfs	20.3 ft	0.81 ft	25.2	1.9 ft

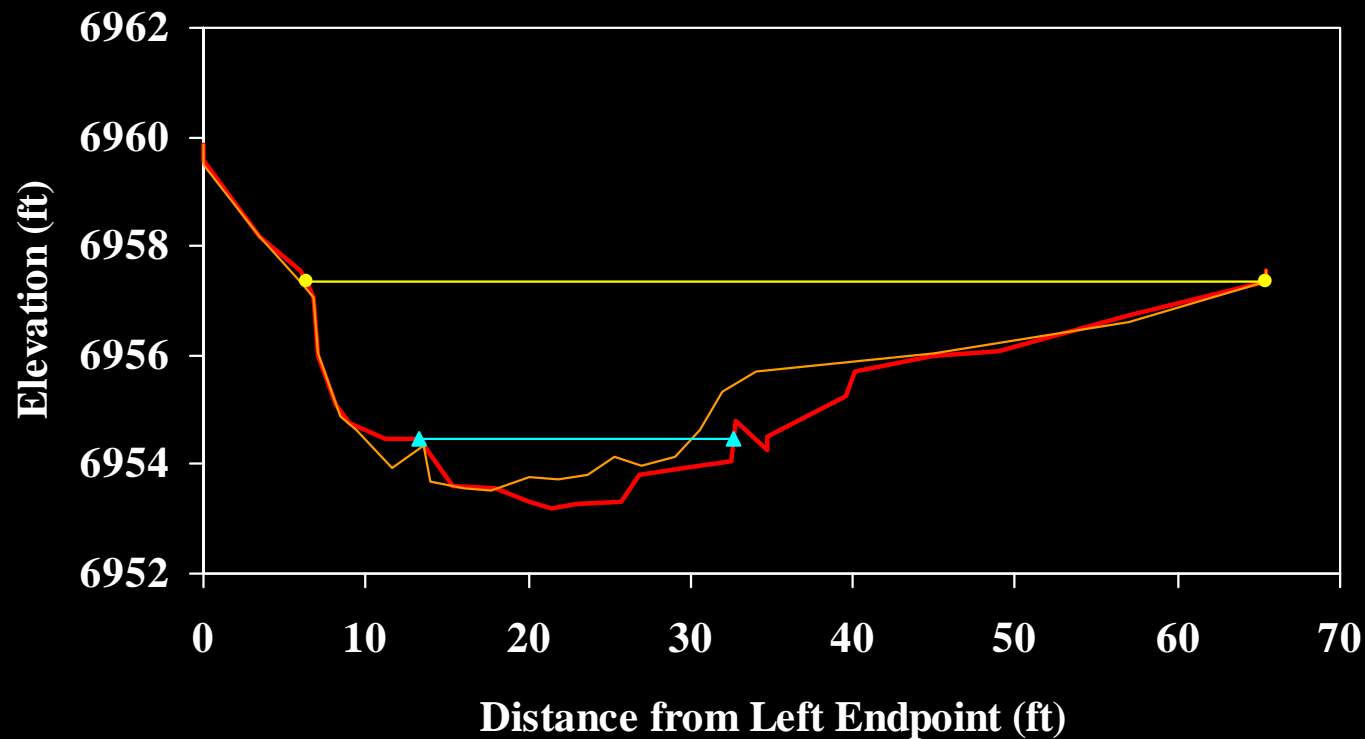
# Cross Section C

Discharge	Width	Mean Depth	Width/Depth Ratio	Max Depth
18 cfs	19.4 ft	0.83 ft	23.4	1.3 ft

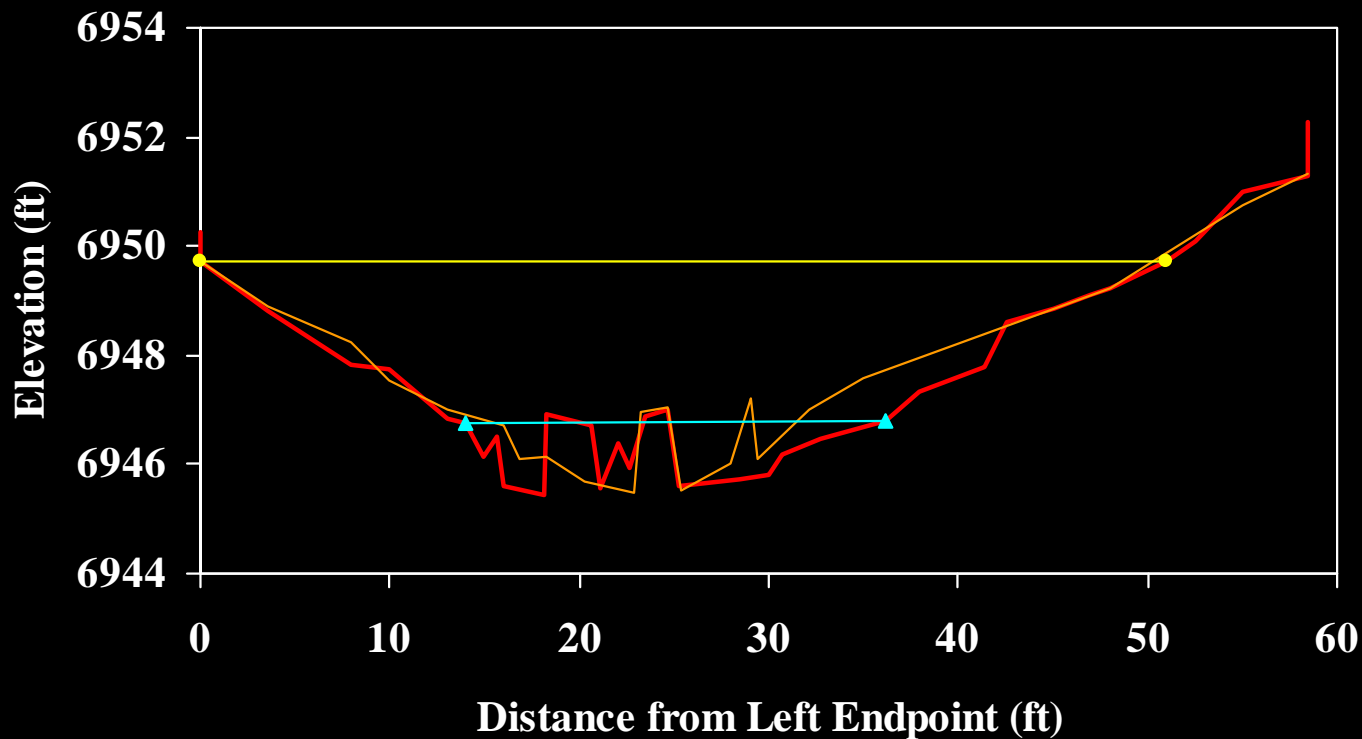
# Cross Section 33+72

Discharge	Width	Mean Depth	Width/Depth Ratio	Max Depth
18 cfs	18.6 ft	0.68 ft	27.5	1.3 ft

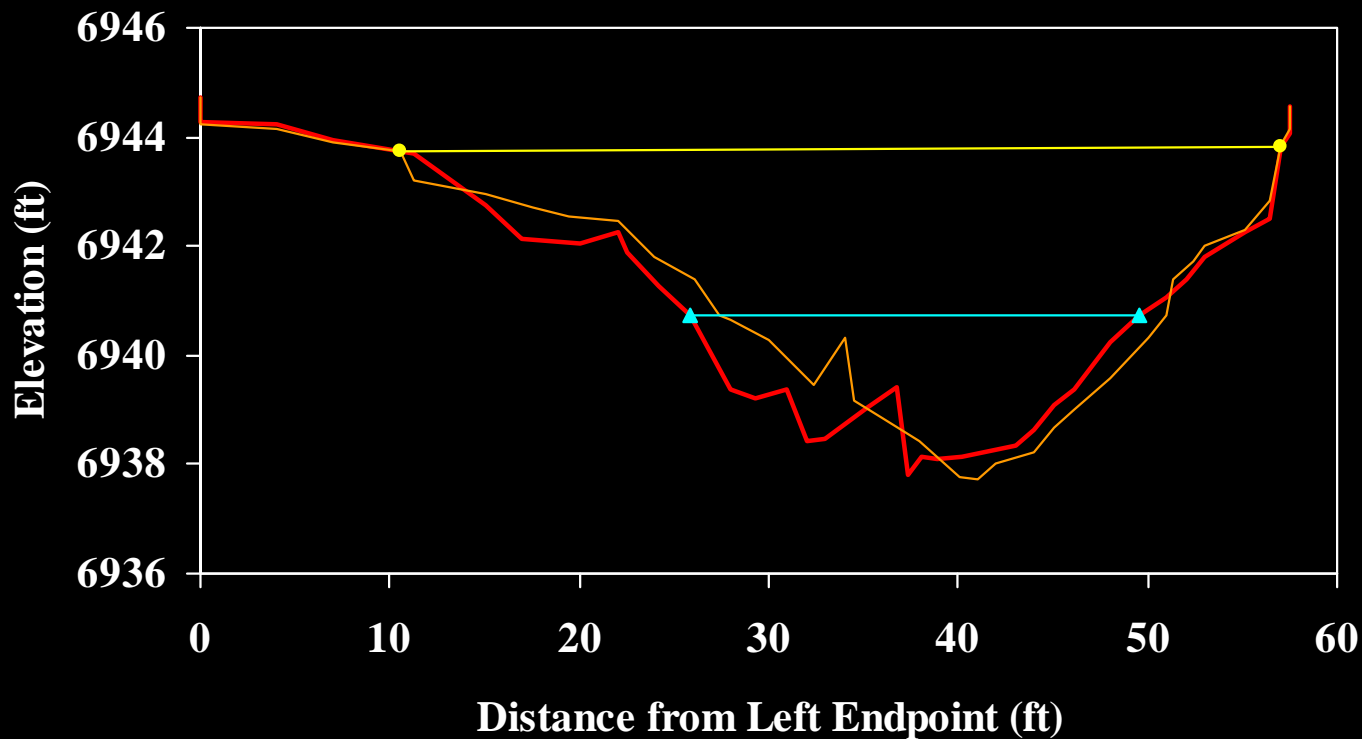
# Cross Section 40+00

Discharge	Width	Mean Depth	Width/Depth Ratio	Max Depth
18 cfs	23.7 ft	1.68 ft	14.0	2.9 ft

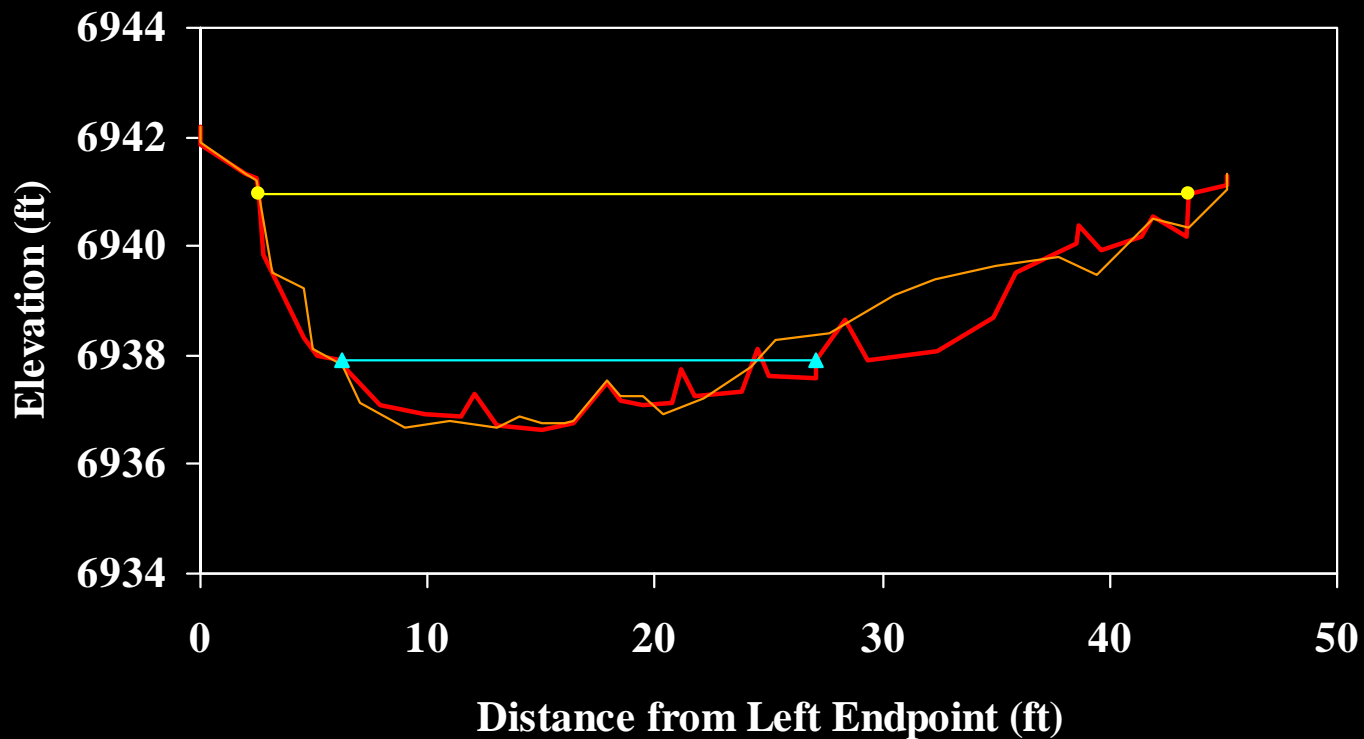
# Cross Section 42+00

Discharge	Width	Mean Depth	Width/Depth Ratio	Max Depth
18 cfs	20.9 ft	0.72 ft	29.1	1.3 ft

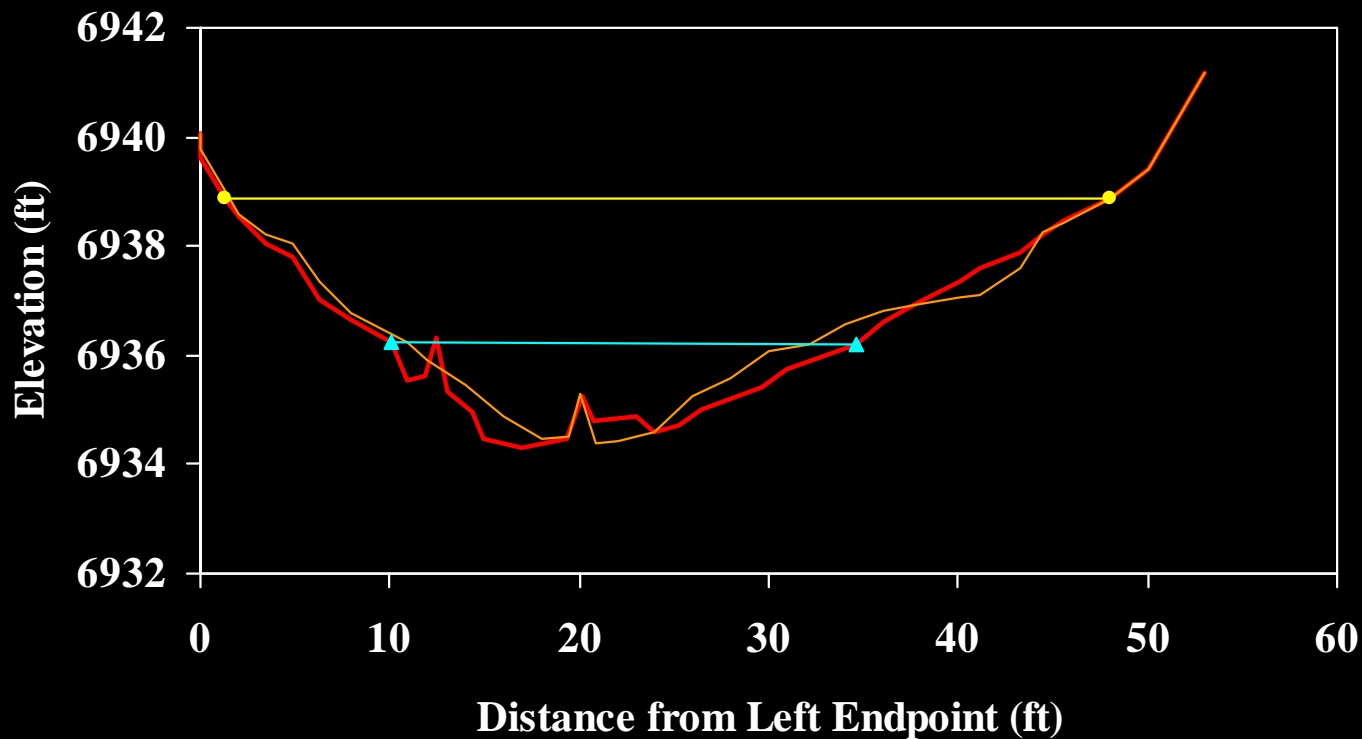
# Cross Section 44+00

Discharge	Width	Mean Depth	Width/Depth Ratio	Max Depth
18 cfs	24.5 ft	1.09 ft	22.5	1.9 ft

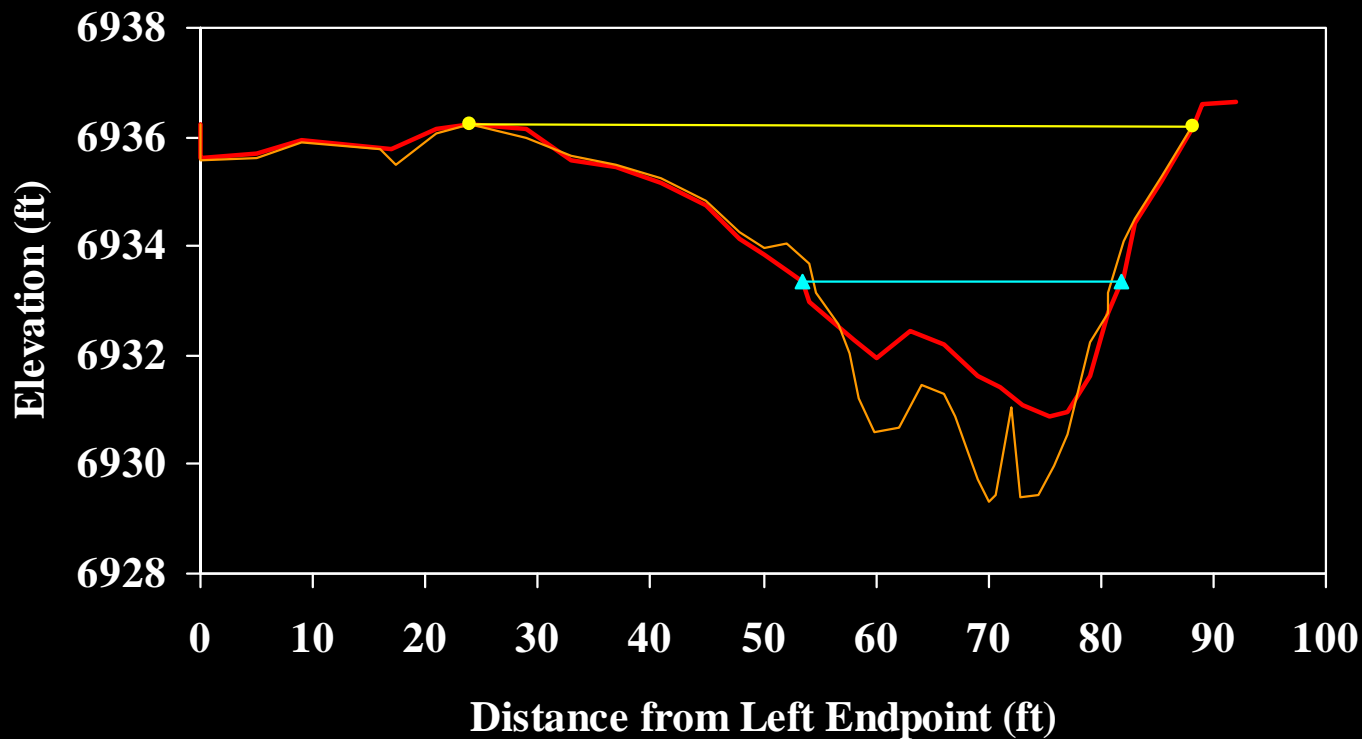
# Cross Section 48+00

Discharge	Width	Mean Depth	Width/Depth Ratio	Max Depth
22 cfs	28.3 ft	1.4 ft	20.2	2.5 ft

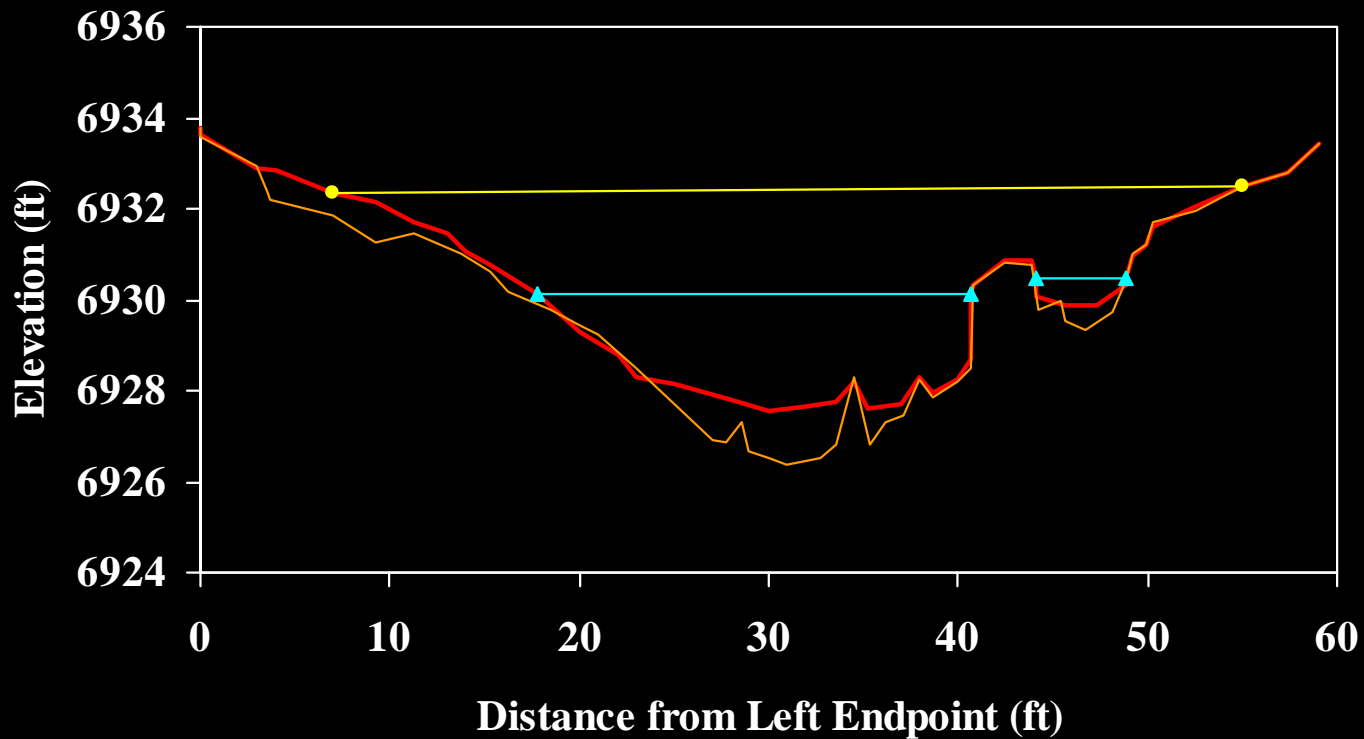
# Cross Section 50+00

Discharge	Width	Mean Depth	Width/Depth Ratio	Max Depth
22 cfs	27.7 ft	1.67 ft	16.6	2.6 ft

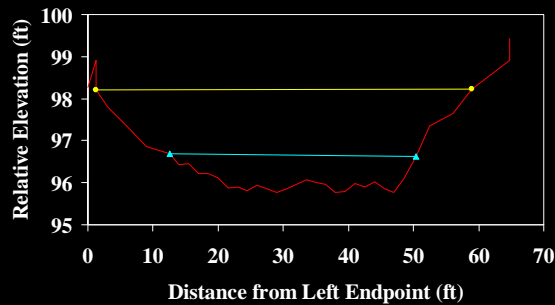
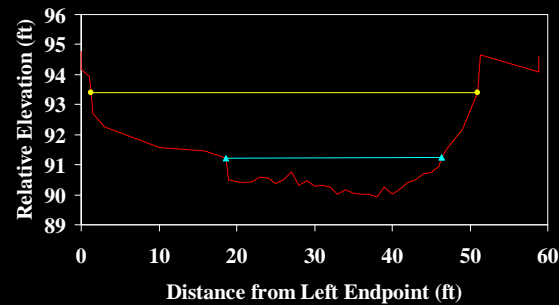
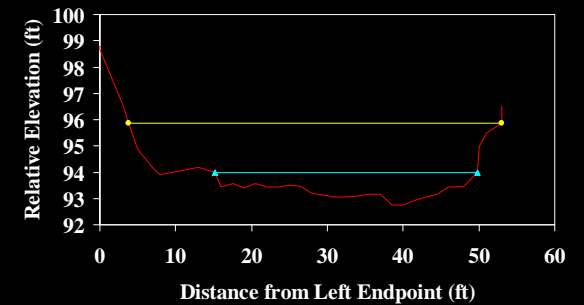
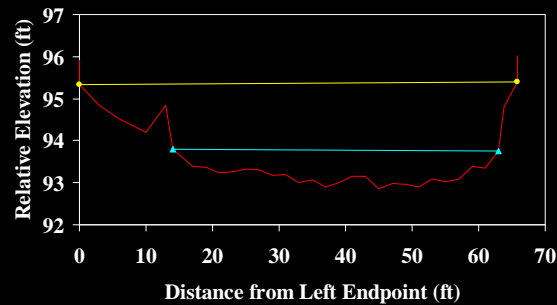
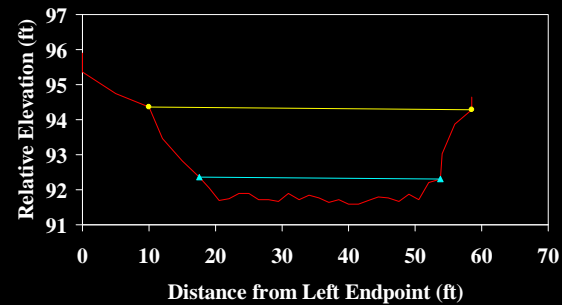
# Division of Wildlife Cross Sections (Surveyed Prior to Construction)

Discharge	Width*	Mean Depth*	Width/Depth Ratio*	Max Depth*
33 cfs	37.1 ft	0.67 ft	57.9	1.0ft

\*Average values from 5 cross sections at 33 cfs

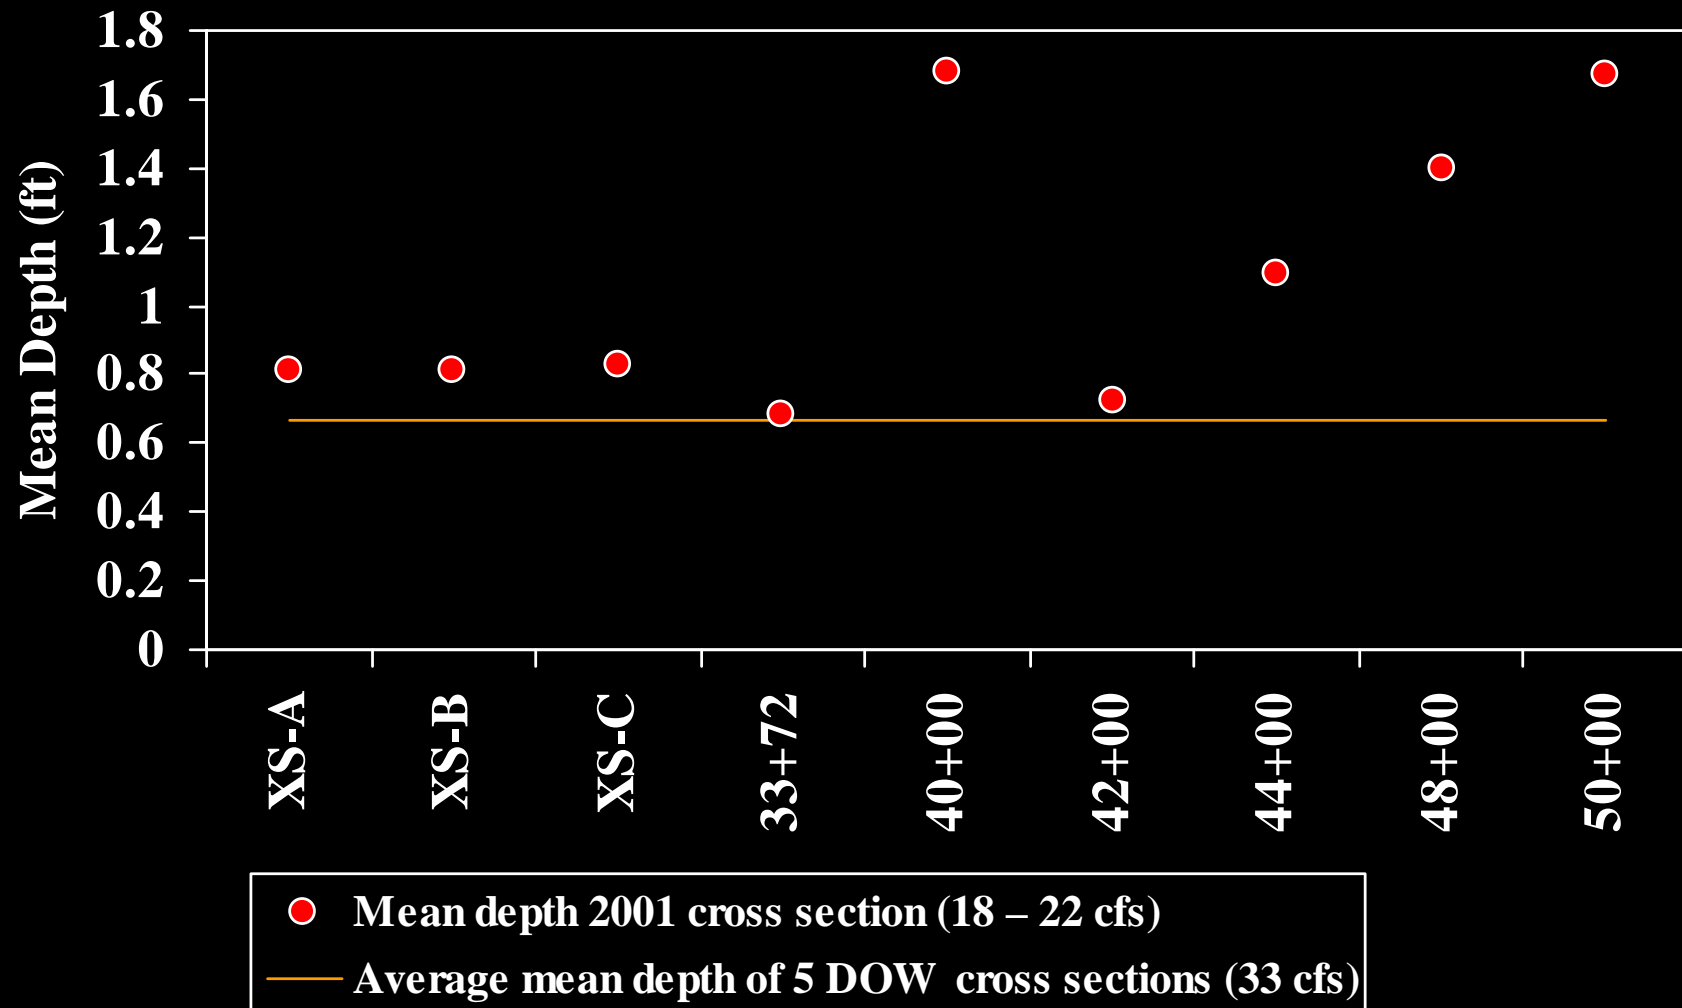
Even with 33 percent less flow, the mean depths of the 2001 cross sections are greater than the average mean depth of 5 Division of Wildlife pre-restoration cross sections.

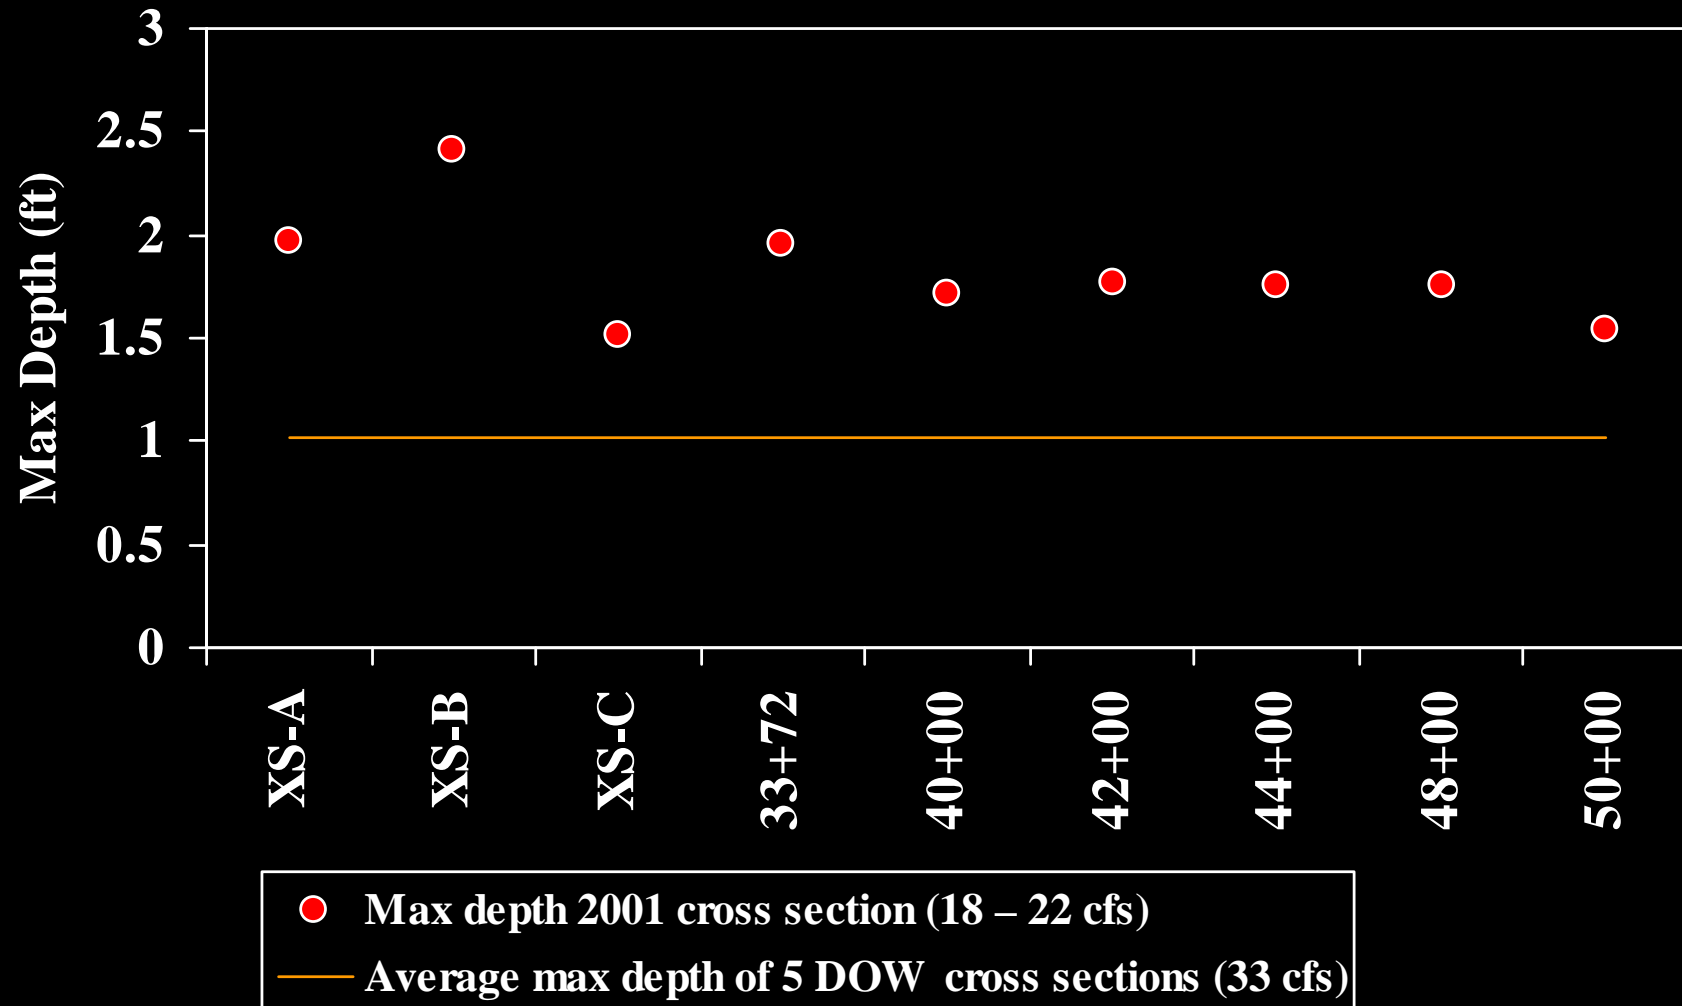
Even with 33 percent less flow, the max depths of the 2001 cross sections are greater than the average max of 5 Division of Wildlife pre-restoration cross sections.

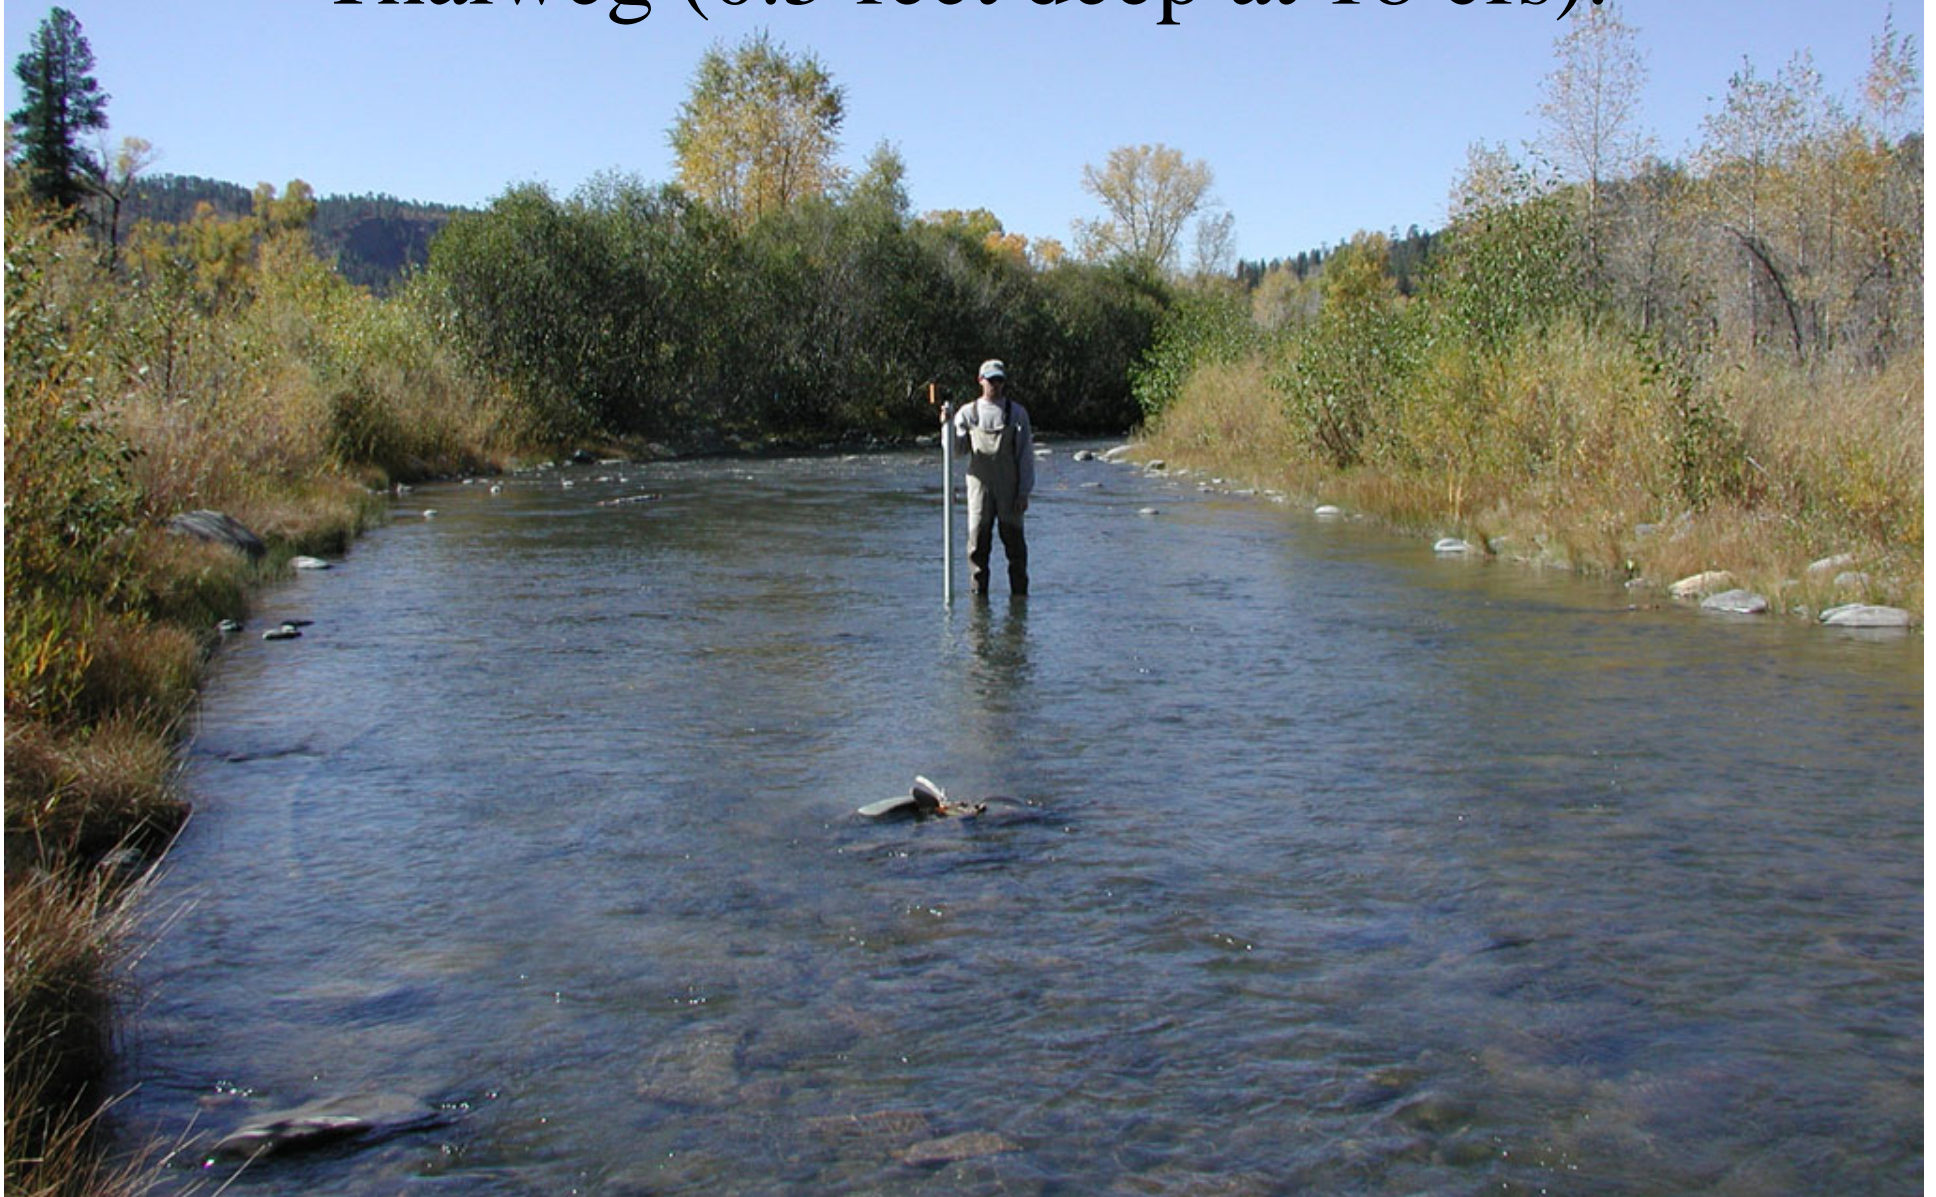
Below the Restored Reach: Poorly Formed  
Thalweg (0.5 feet deep at 18 cfs).

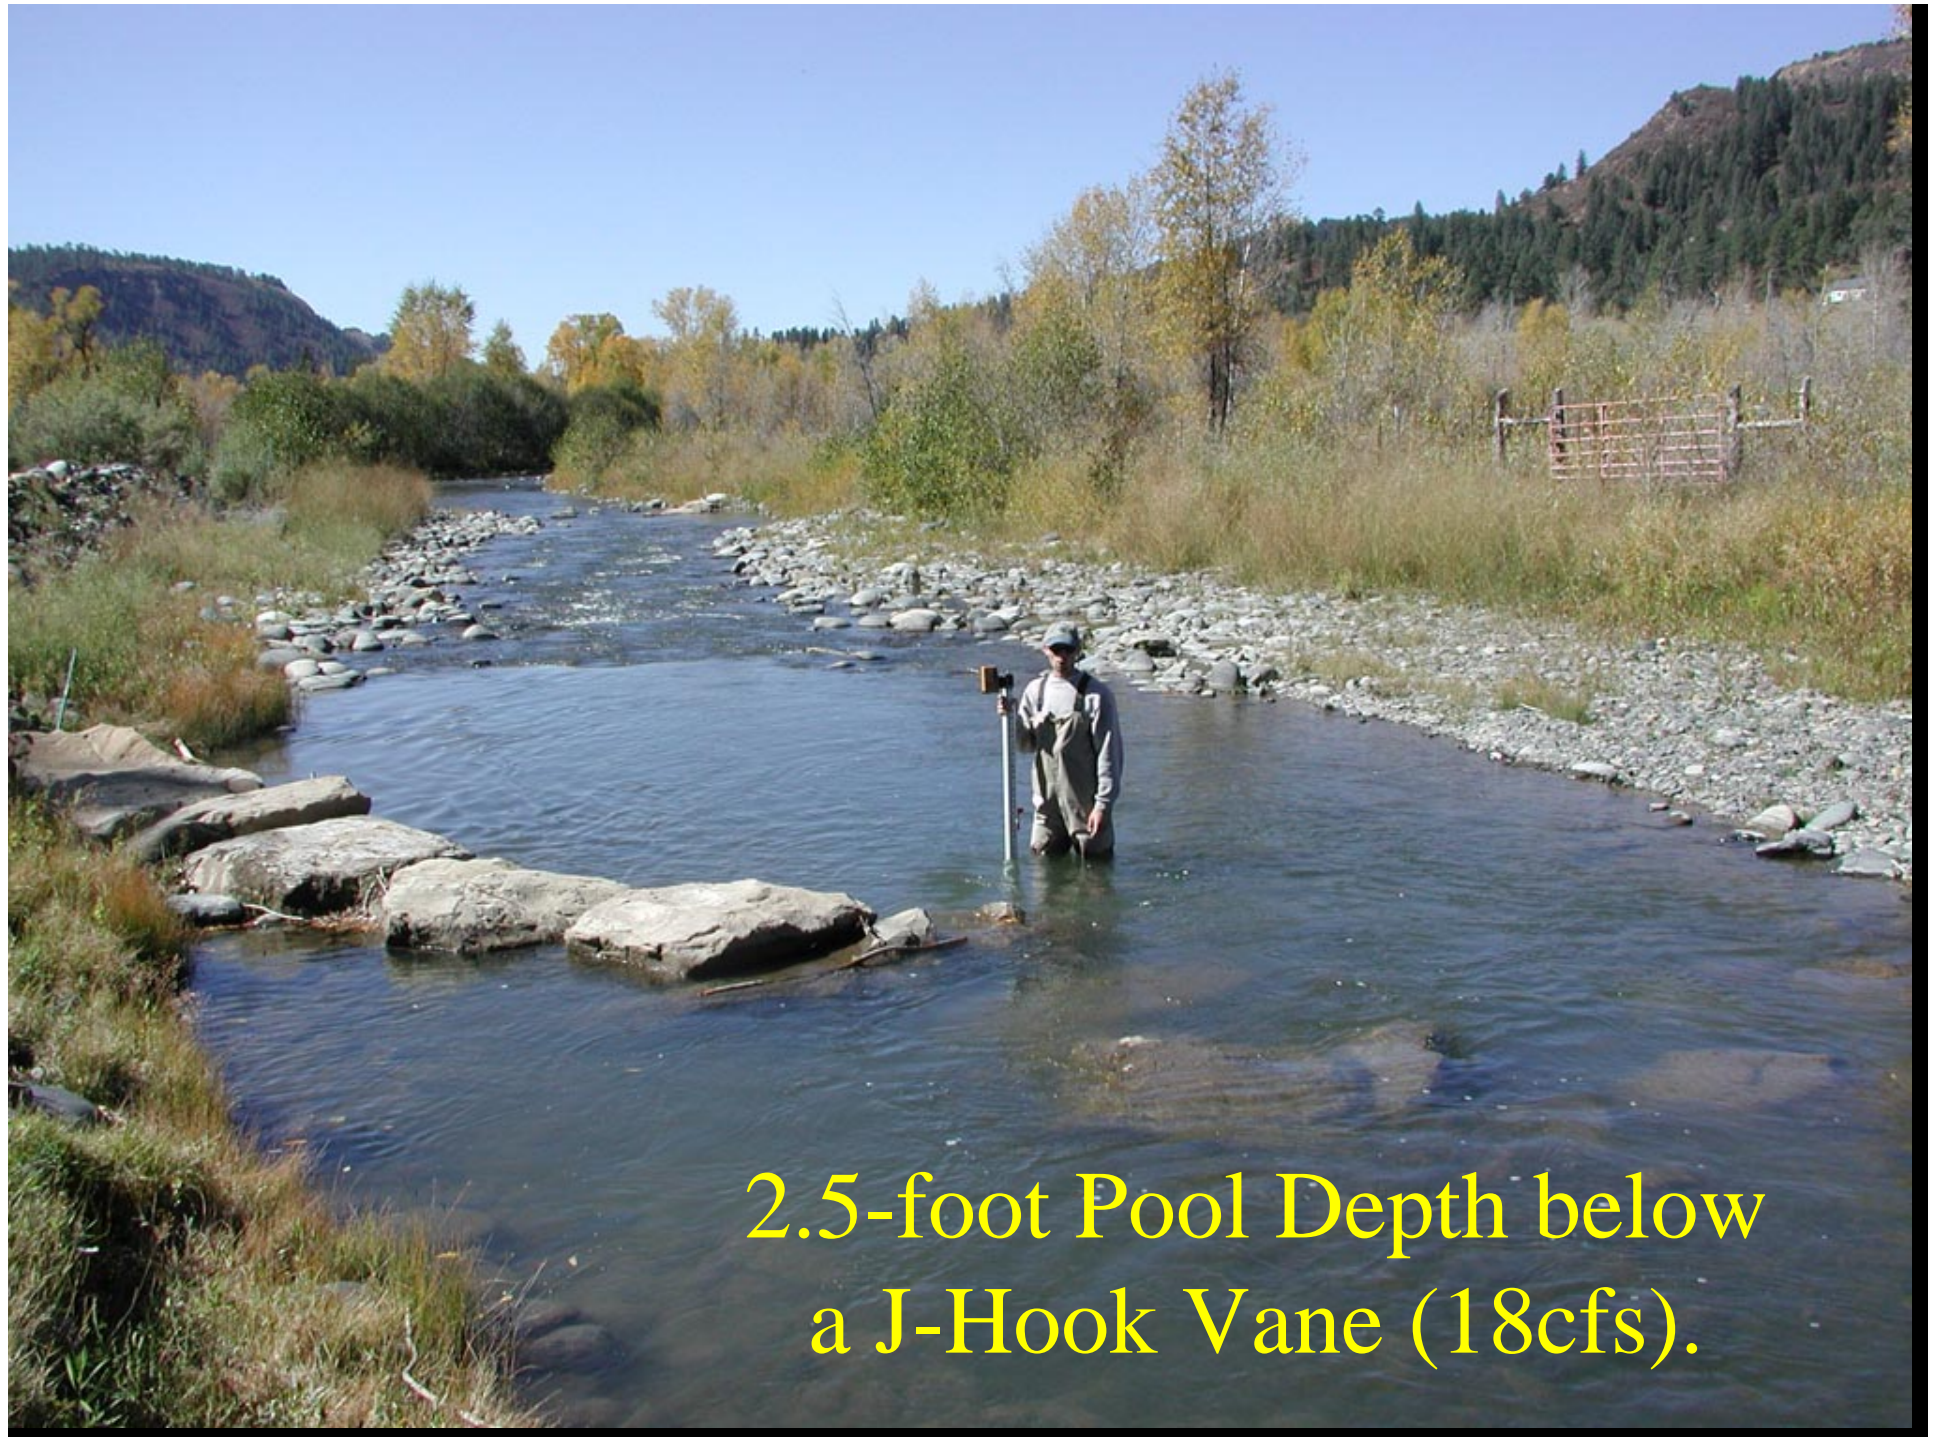
2.5-foot Pool Depth below  
a J-Hook Vane (18cfs).

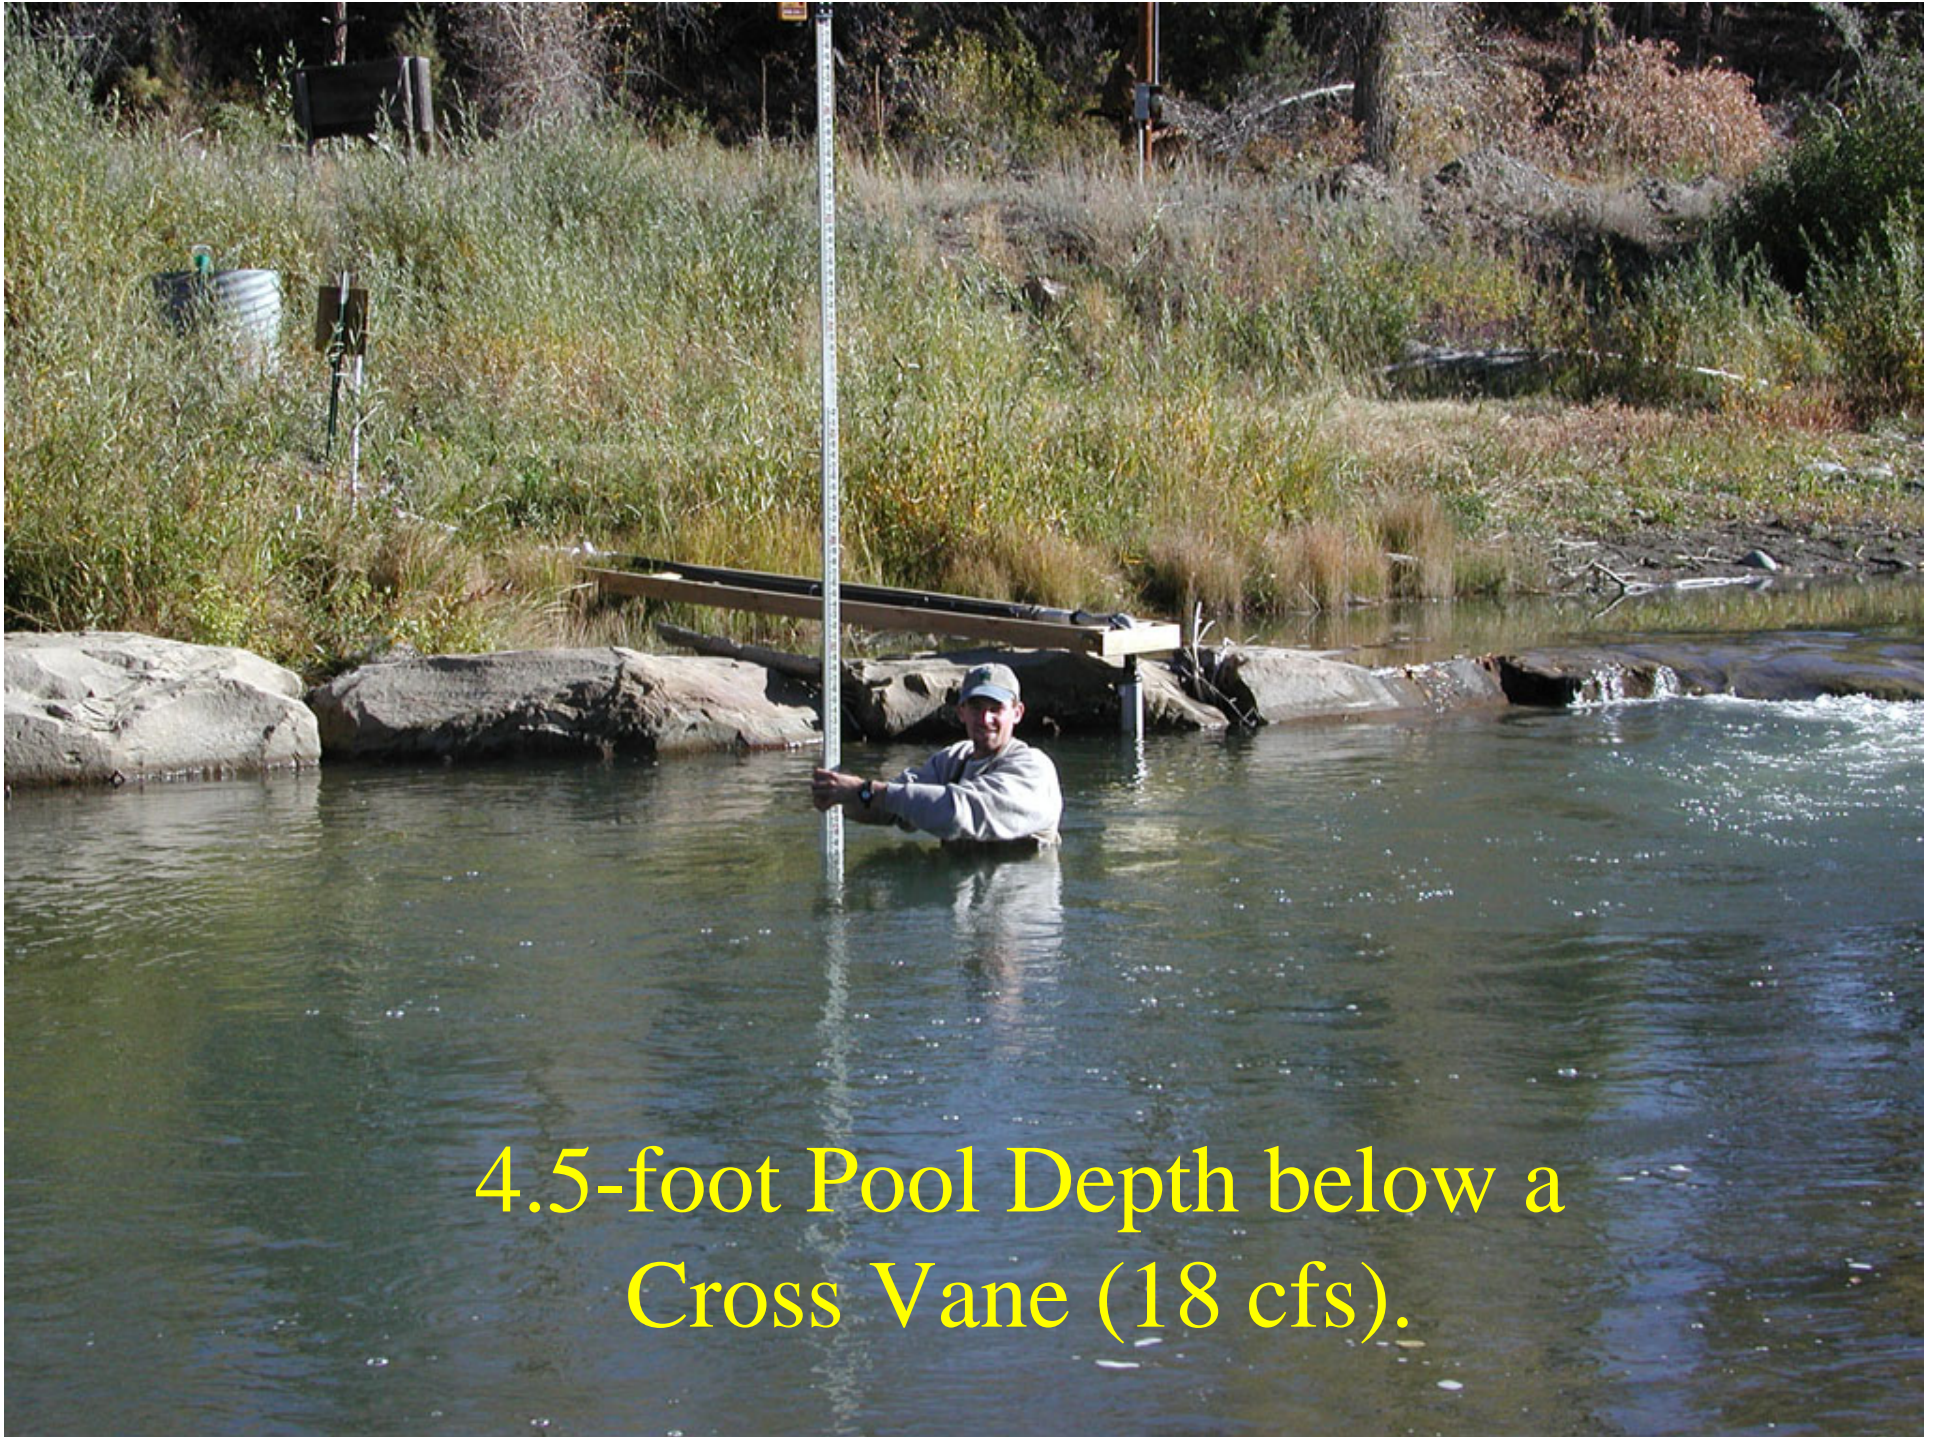
4.5-foot Pool Depth below a  
Cross Vane (18 cfs).
