# **STOLLSTEIMER CREEK WATERSHED**

## **MASTER PLAN**

**July, 2006**

# **Stollsteimer Creek Watershed Master Plan**

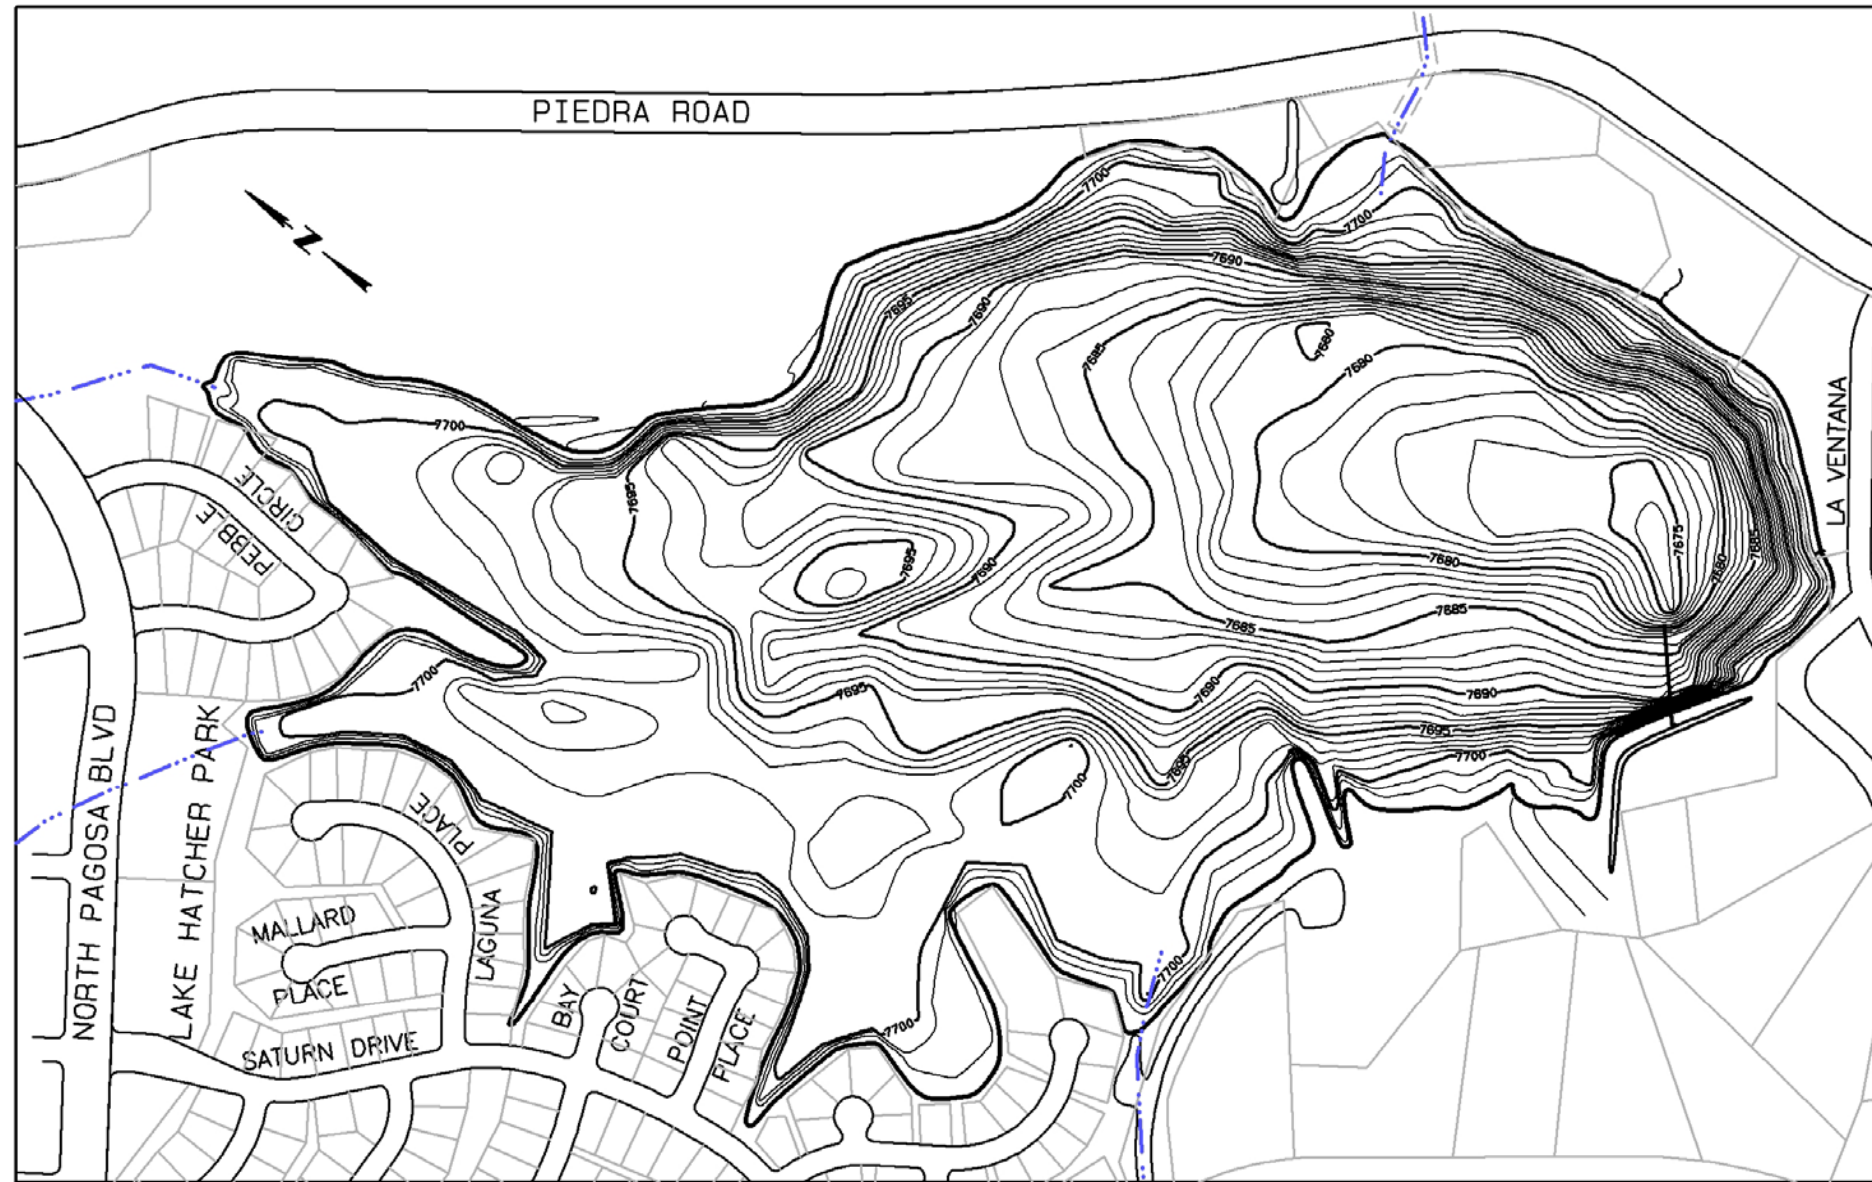
# Hatcher Lake

LAKE BOTTOM CONTOURS

Scale: 1" = 400 ft

The other four lakes, Forest, Pagosa, Village and Hatcher all have poorly documented capacity information. The Watershed Steering Committee felt that it was important to complete hydrographic surveys of these four lakes as part of the watershed master plan effort. Hydrographic surveys would result in detailed stage/storage curves, as well as lake bottom contour mapping and assessments of opportunities to expand storage capacity and/or reduce bottom rooted vegetation problems. A local engineering firm was retained to accomplish hydrographic surveys for these four lakes. Ground survey equipment and depth sounding sonar equipment were used to build 3D surface models of the lake bottoms. Existing spillways were measured and stage/discharge rating curves were established for each of the lakes. Maps of the bottom contours for each of these four lakes are included in this report. A summary of lake capacity information is included below.

Lake Name	Surface Area (AC)	Maximum Storage Volume (AC-FT)
Hatcher Lake	130	1368
Lake Pagosa	106	1252
Village Lake	80	643
Lake Forest	42	272
Stevens Lake (above spillway)	N/A	921 @ 5 ft depth
Pinõn Lake	38	N/A
