# Monitoring Restoration Effectiveness on the Lower Rio Blanco River

J.D. Kurz<sup>1</sup> and D.L. Rosgen<sup>2</sup>

Wildland Hydrology, Pagosa Springs, CO

# Lower Rio Blanco River near Pagosa Springs, Colorado

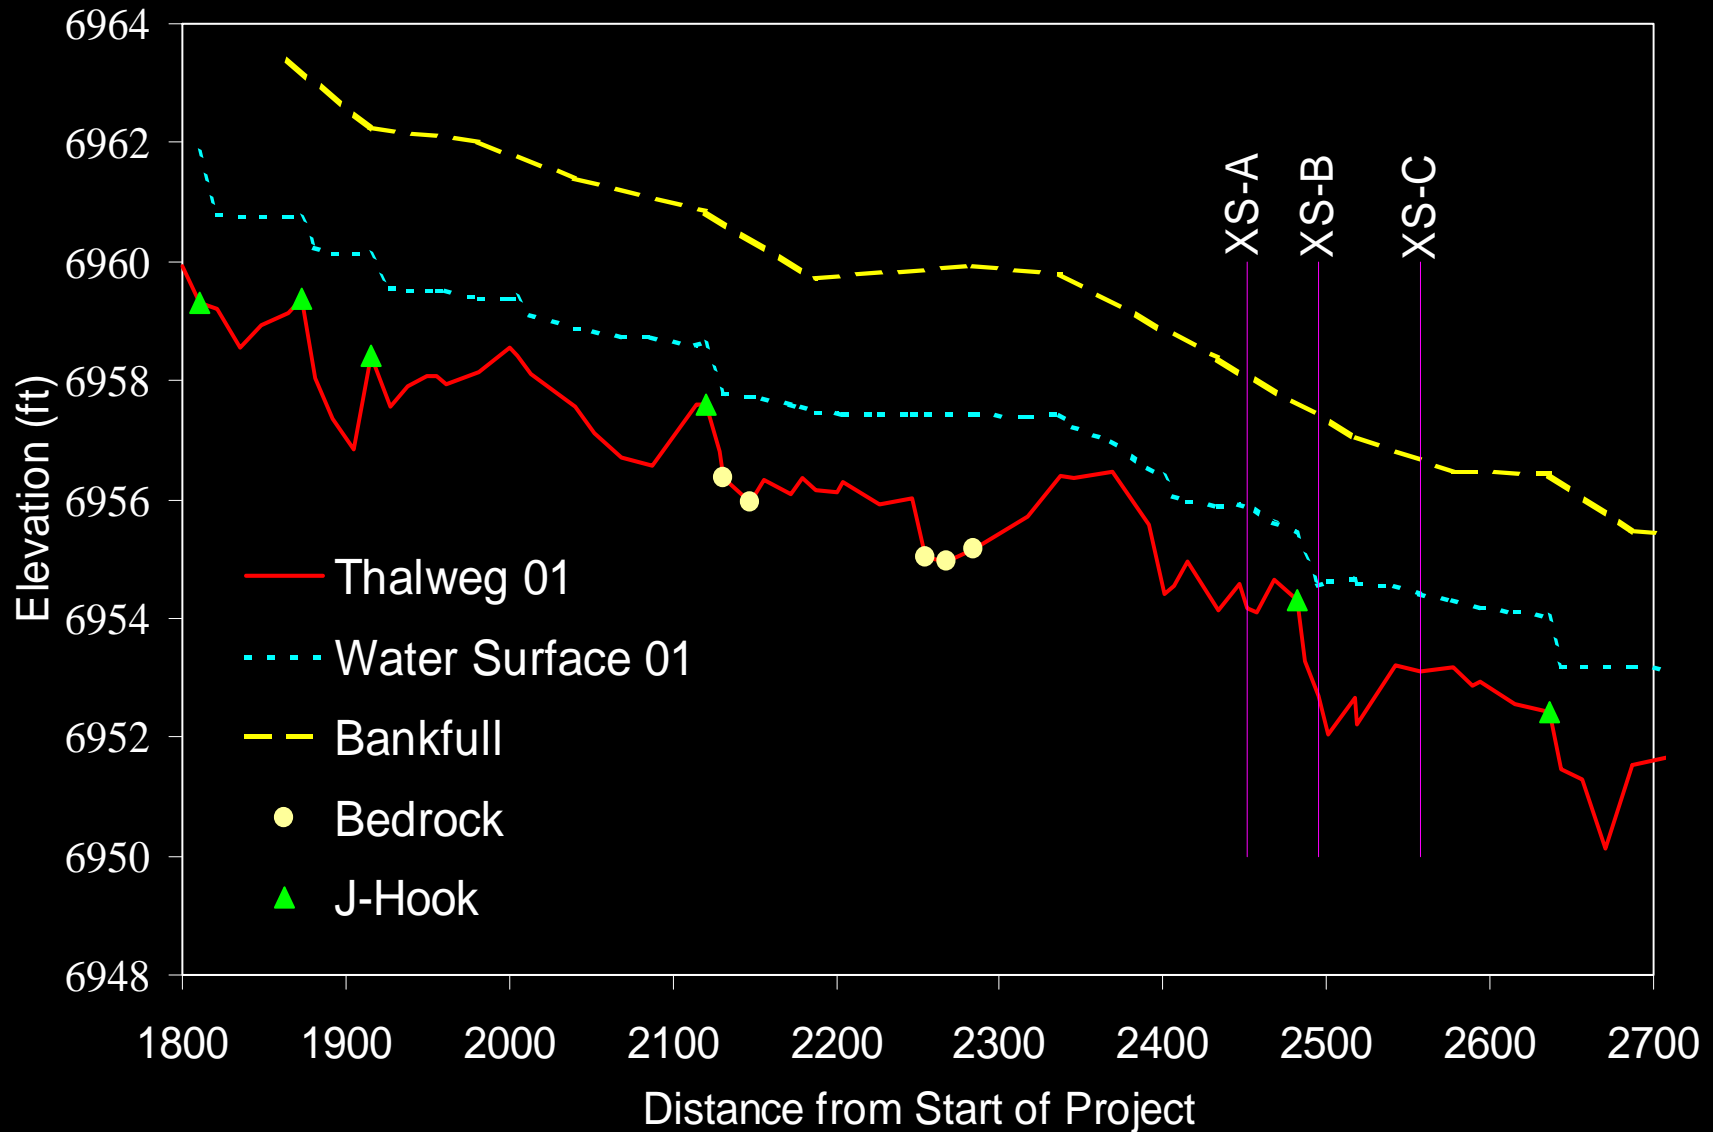
# Longitudinal Profile through Cross Sections A, B, and C

- Permanent cross sections were installed following construction to monitor channel change.
- A longitudinal profile was surveyed through the entire project length.
- Resurveyed following the 2001 spring runoff , which provided excellent test of the restoration stability (1040 cfs).

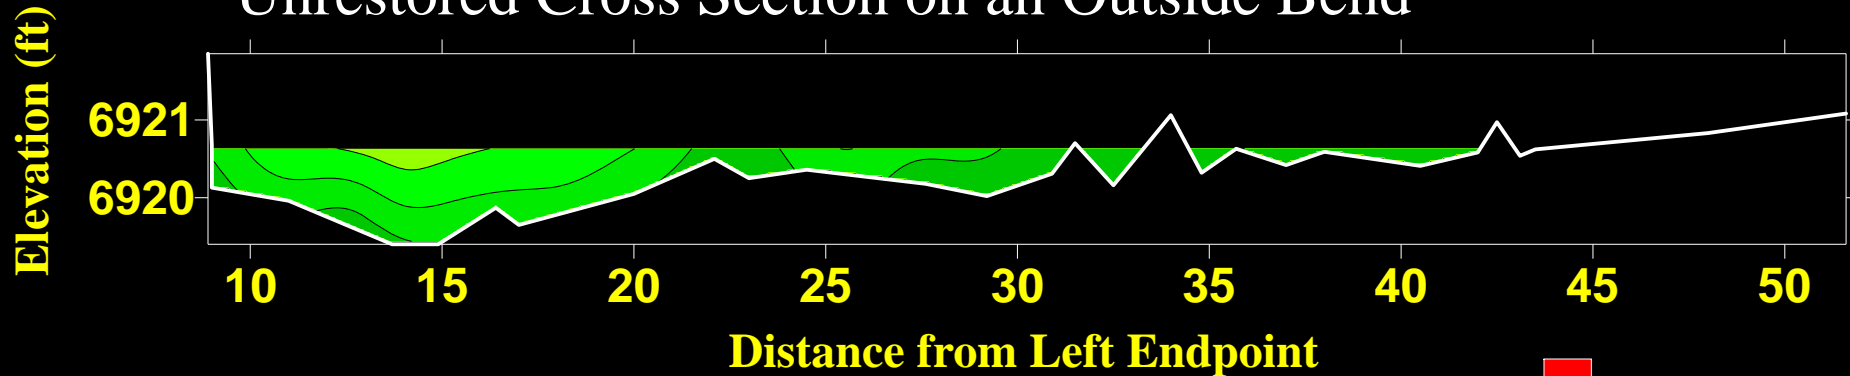
## Unrestored Cross Section on an Outside Bend

# Comparing Velocity Distribution at 2 Cross Sections
